## PRESERVATION BRIEFS

## The Repair of Historic Wooden Windows

John H. Myers

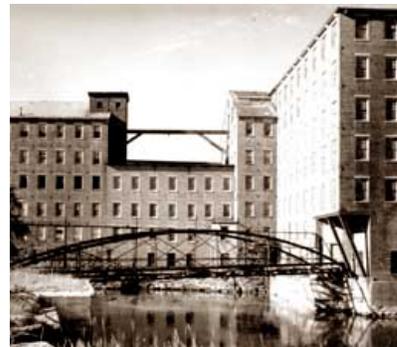
Windows are frequently important visual focal points, especially on simple facades such as this mill building. Replacement of the multi-pane windows with larger panes could dramatically alter the appearance of the building. Photo: NPS files.

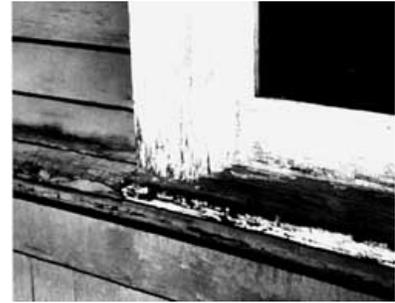
Deterioration of poorly maintained windows usually begins on horizontal surfaces and at joints, where water can collect and saturate the wood. Photo: NPS files.

Many factors such as poor design, moisture, vandalism, insect attack, and lack of maintenance can contribute to window deterioration, but moisture is the primary contributing factor in wooden window decay. All window units should be inspected to see if water is entering around the edges of the frame and, if so, the joints or seams should be caulked to eliminate this danger. The glazing putty should be checked for cracked, loose, or missing sections which allow water to saturate the wood, especially at the joints. The back putty on the interior side of the pane should also be inspected, because it creates a seal which prevents condensation from running down into the joinery. The sill should be examined to insure that it slopes downward away from the building and allows water to drain off. In addition, it may be advisable to cut a dripline along the underside of the sill. This almost invisible treatment will insure proper water runoff, particularly if the bottom of the sill is flat. Any conditions, including poor original design, which permit water to come in contact with the wood or to puddle on the sill must be corrected as they contribute to deterioration of the window.

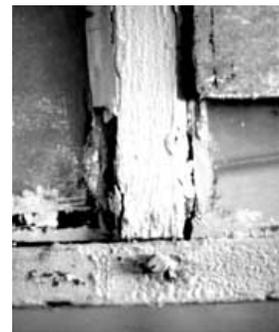
This historic double-hung window has many layers of paint, some cracked and missing putty, slight separation at the joints, broken sash cords, and one cracked pane. Photo: NPS files.

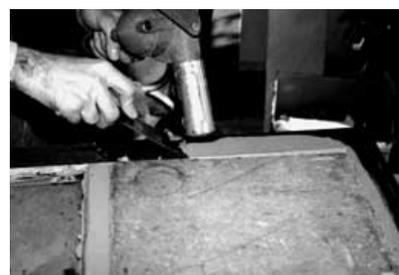
Sash can be removed and repaired in a convenient work area. Paint is being removed from this sash with a hot air gun. Photo: NPS files.

The sash can be stripped of paint using appropriate techniques, but if any heat treatment is used, the glass should be removed or protected from the sudden temperature change which can cause breakage. An overlay of aluminum foil on gypsum board or asbestos can protect the glass from such rapid temperature change. It is important to protect the glass because it may be historic and often adds character to the window. Deteriorated putty should be removed manually, taking care not to damage the wood along the rabbet. If the glass is to be removed, the glazing points which hold the glass in place can be extracted and the panes numbered and removed for cleaning and reuse in the same openings. With the glass panes out, the remaining putty can be removed and the sash can be sanded, patched, and primed with a preservative primer. Hardened putty in the rabbets may be softened by heating with a soldering iron at the point of removal. Putty remaining on the glass may be softened by soaking the panes in linseed oil, and then removed with less risk of breaking the glass. Before reinstalling the glass, a bead of glazing compound or linseed oil putty should be laid around the rabbet to cushion and seal the glass. Glazing compound should only be used on wood which has been brushed with linseed oil and primed with an oil based primer or paint. The pane is then pressed into place and the glazing points are pushed into the wood around the perimeter of the pane.

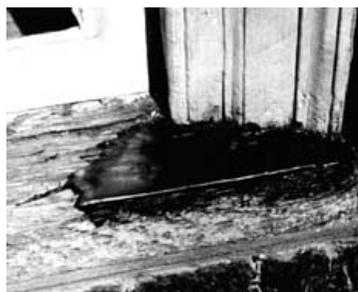
This illustrates a two-part epoxy patching compound used to fill the surface of a weathered sill and rebuild the missing edge. When the epoxy cures, it can be sanded smooth and painted to achieve a durable and waterproof repair. Photo: NPS files.

Wood may also be strengthened and stabilized by consolidation, using semirigid epoxies which saturate the porous decayed wood and then harden. The surface of the consolidated wood can then be filled with a semirigid epoxy patching compound, sanded and painted. Epoxy patching compounds can be used to build up missing sections or decayed ends of members. Profiles can be duplicated using hand molds, which are created by pressing a ball of patching compound over a sound section of the profile which has been rubbed with butcher's wax. This can be a very efficient technique where there are many typical repairs to be done. The process has been widely used and proven in marine applications; and proprietary products are available at hardware and marine supply stores. Although epoxy materials may be comparatively expensive, they
